Manhole Inspection Summary

Manhole # S41E__018MH

Insp Date: **5/21/08 2:26 PM**

Location Address: **12 n spring st**

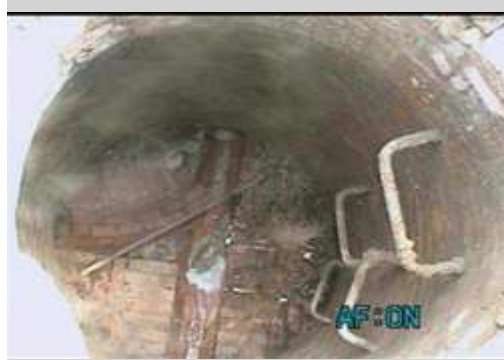
Top View

top view & steps

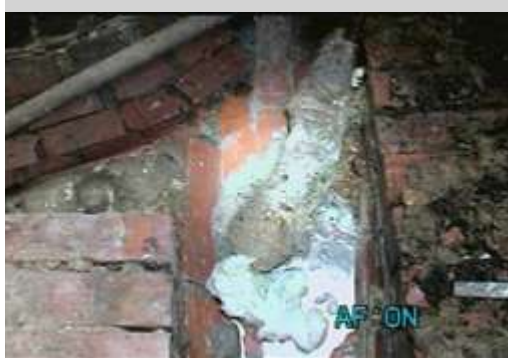
Defect 3

Condition: ☐ Sound ☐ Cracked ☐ Root Intrusion ☐ Deteriorated ☐ Leaks ☒ **Debris**

channel debris

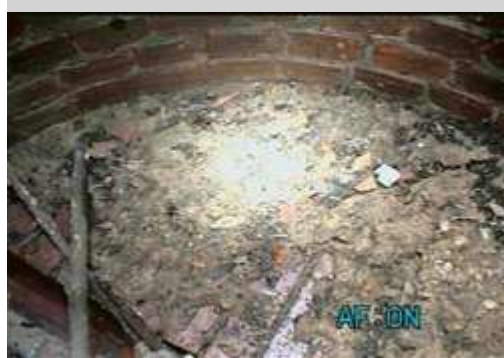
Defect 2

Condition: ☐ Sound ☐ Cracked ☐ Root Intrusion ☐ Deteriorated ☐ Leaks ☒ **Debris**

bench debris

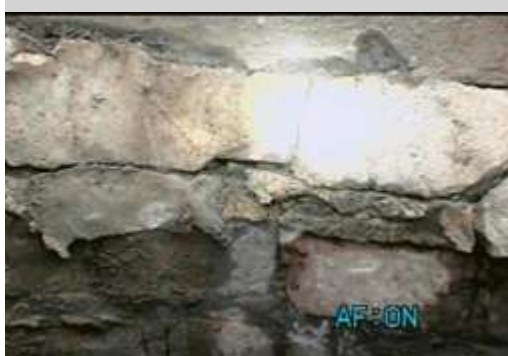
Defect 1

Condition: ☐ Sound ☒ **Cracked** ☐ Root Intrusion ☒ **Loose Brick** ☐ Deteriorated

cracked chimney loose bricks frame adj.

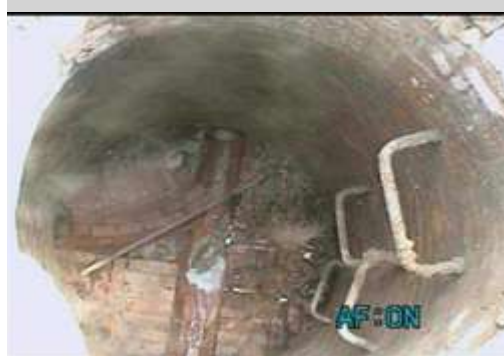
Defect 4

Count: **4** Missing: **0** ☒ **Corroded**

corroded steps

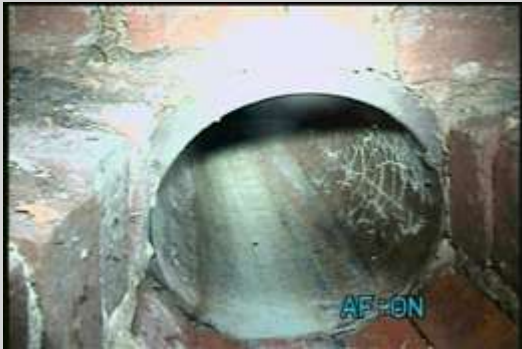
12 O'Clock Outflow

8 in. Circular Gravity Sewer
Pipe Out @ 12 O'Clock

Invert Depth: **9.13** (ft.) Flow Characteristics: **Slow**

Deposits: ☒ None ☐ Mud ☐ Sludge ☐ Debris ☐ Grease

Infiltration: **None** Pipe Seal Cond: **Unknown**

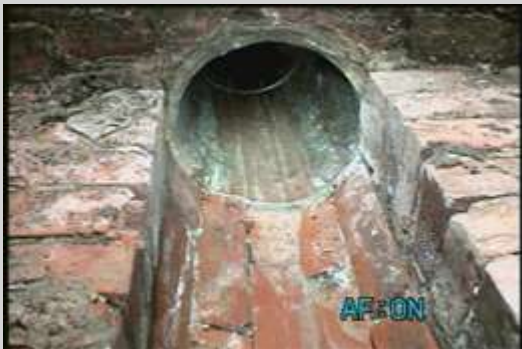
6 O'Clock Inflow

8 in. Circular Gravity Sewer
Pipe In @ 6 O'Clock

Invert Depth: **8.76** (ft.) Flow Characteristics: **Fast**

Deposits: ☒ None ☐ Mud ☐ Sludge ☐ Debris ☐ Grease

Infiltration: **None** Pipe Seal Cond: **Unknown**

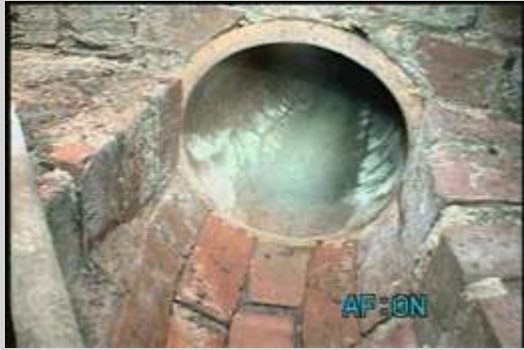
9 O'Clock Inflow

8 in. Circular Gravity Sewer

Pipe In @ 9 O'Clock

Invert Depth: **8.77** (ft.) Flow Characteristics: **None**

Deposits: ☒ None ☐ Mud ☐ Sludge ☐ Debris ☐ Grease

Infiltration: **None** Pipe Seal Cond: **Unknown**
